Subject: *Request for Preliminary Determination*
Proposed Fence Installation, Building Demolition and Debris Removal Project,
BASF, 167 & 180 Mill Street, Cranston, Rhode Island

Request for Preliminary Determination (Rule 9.00)

Debris Removal and Fence Installation Project Cranston, Rhode Island BASF

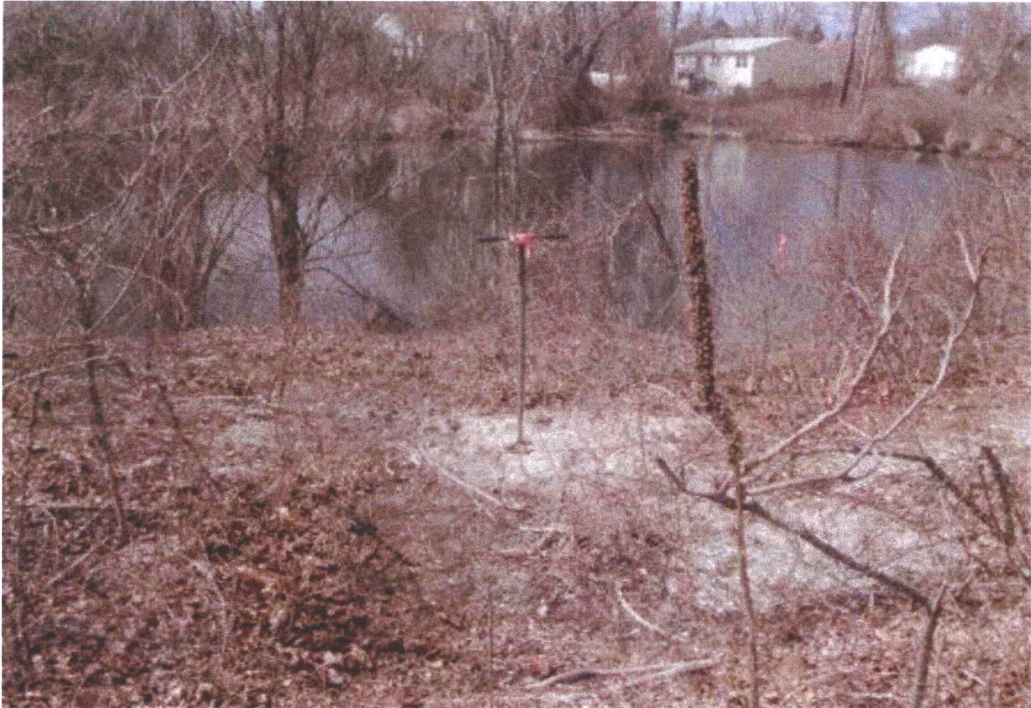
Client Name: BASF		Site Location: Cranston, Rhode Island	Project No. 60163799
Photo No. 1	Date:

Direction Photo Taken: Facing West			
Description: View of Bellefont Pond and pond bank on lot 2563. The northern extent of the proposed fence is to be located in this approximate location.

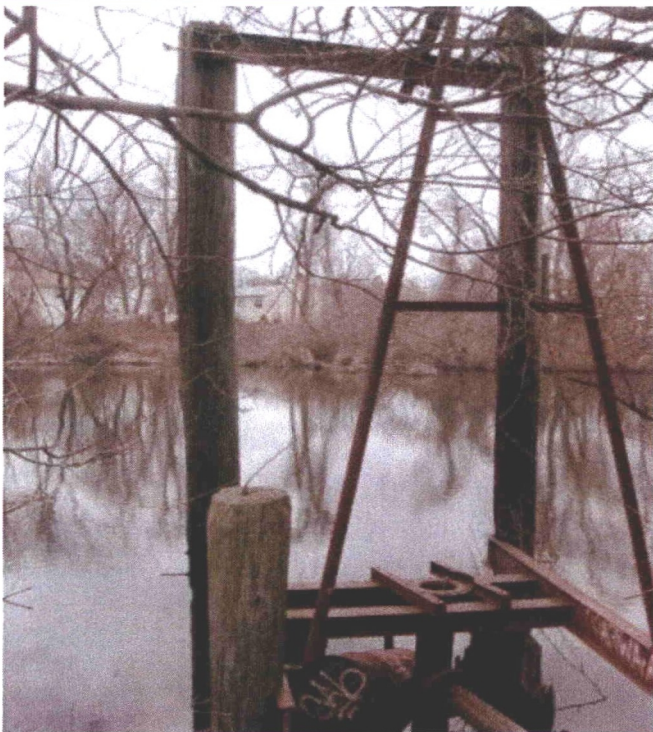
Client Name: BASF		Site Location: Cranston, Rhode Island	Project No. 60163799
Photo No. 3	Date:

Direction Photo Taken: Facing West			
Description: View of fire water intake structure that is to be removed.

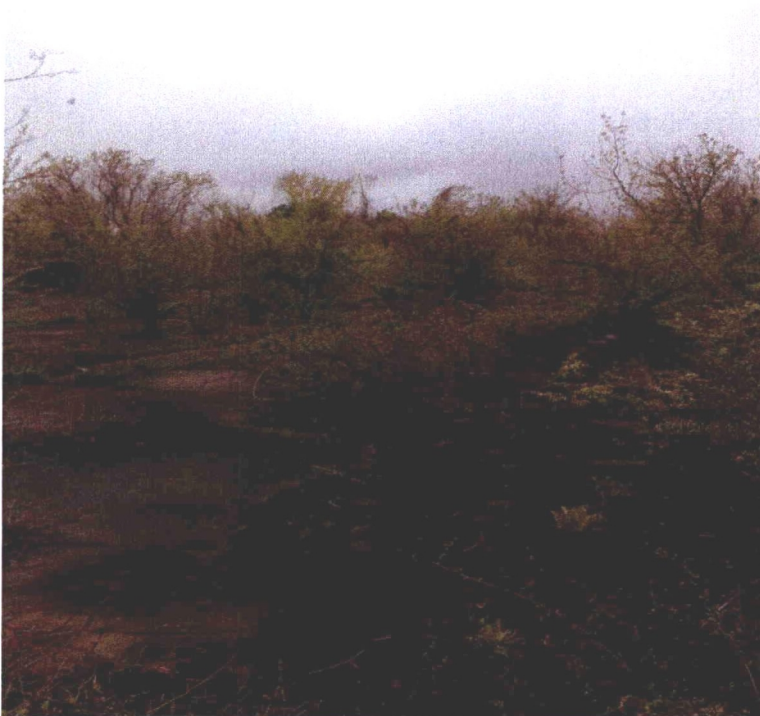
Photo No. 4	Date:

Direction Photo Taken: Facing Southwest		
Description: View of tile plant footprint located on lot 2563 that is to be cleared of vegetation. Vegetation removal is to occur landward of the 50-foot Perimeter Wetland.

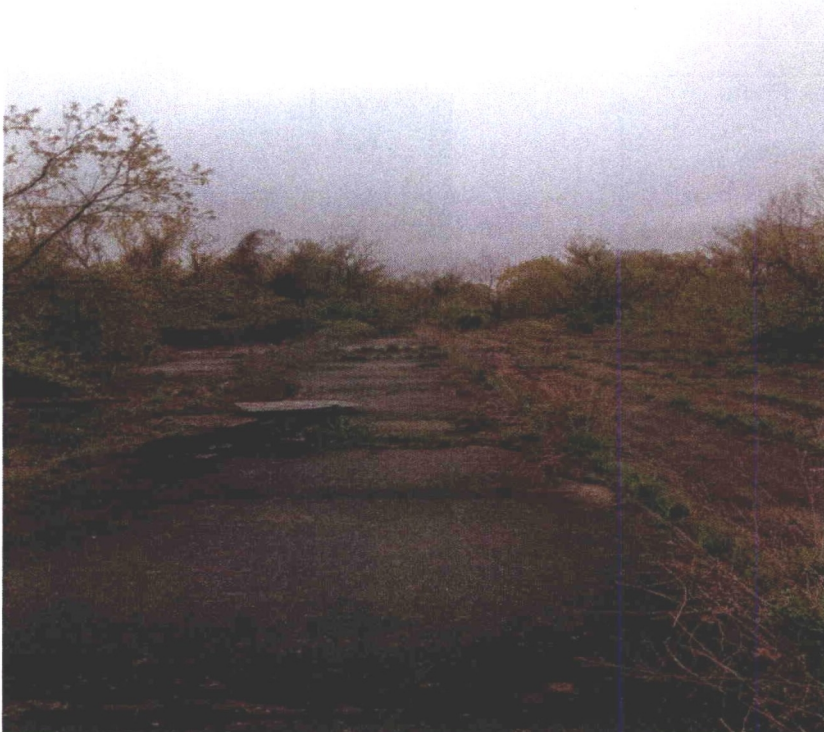
Client Name: BASF		Site Location: Cranston, Rhode Island	Project No. 60163799
Photo No. 5	Date:

Direction Photo Taken: Facing West			
Description: View of debris located on foundation of former tile plant on lot 2563. Debris is to be stockpiled and removed from the site.

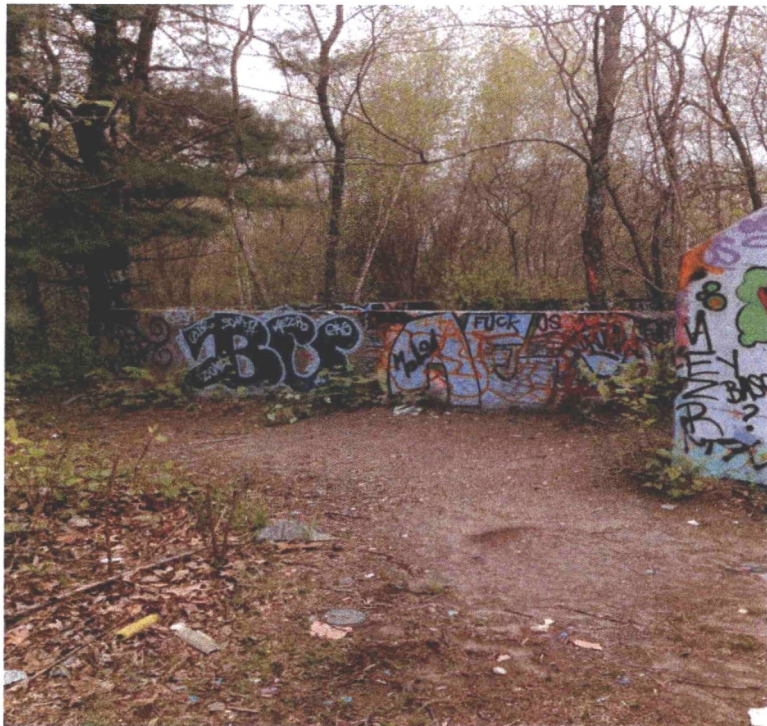
Client Name: BASF		Site Location: Cranston, Rhode Island	Project No. 60163799
Photo No. 7	Date:

Direction Photo Taken: Facing North			
Description: View of remaining foundation located on lot 2682 that is to be removed.

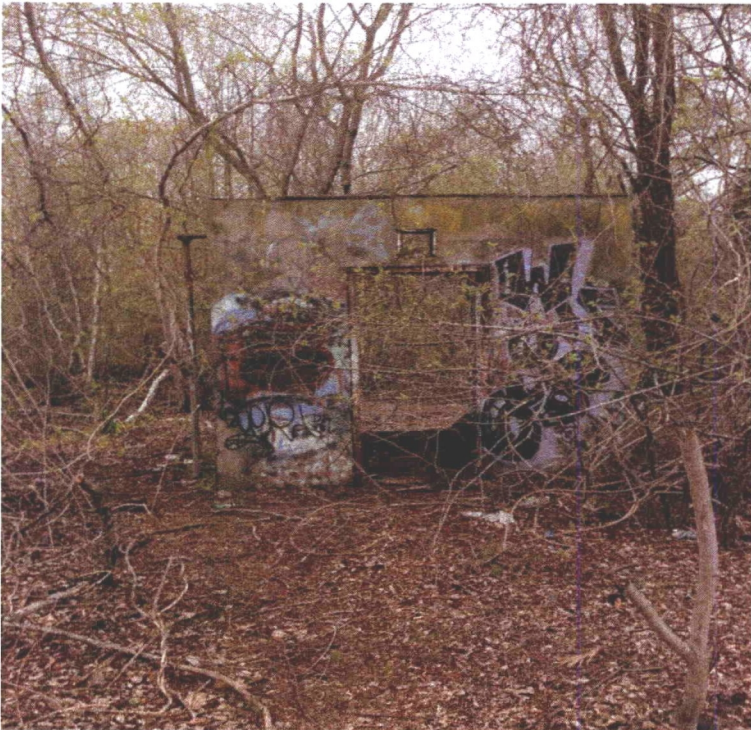
Client Name: BASF		Site Location: Cranston, Rhode Island	Project No. 60163799
Photo No. 9	Date:

Direction Photo Taken: Facing Southwest			
Description: View of former pump house located on lot 2682 that is to be removed

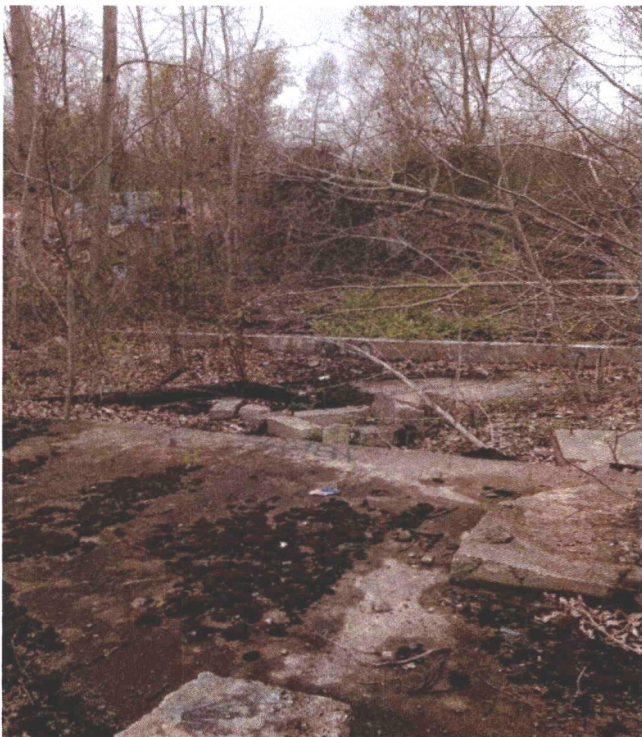
Client Name:		Site Location:	Project No.
Photo No. 11	Date:

Direction Photo Taken: Facing Northwest			
Description: View of remnant foundation and debris located on lot 2682 that is to be removed

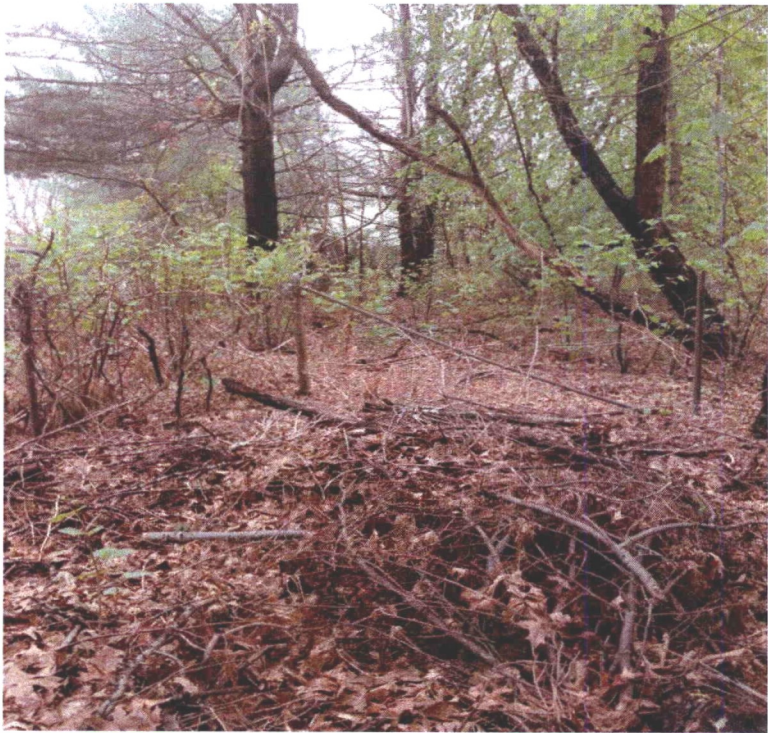
Client Name:		Site Location:	Project No.
Photo No. 13	Date:

Direction Photo Taken: Facing south			
Description: View of fence (missing sections) on lot 2563
